Post-Seismic Capacity of Damaged and Repaired Reinforced Concrete Plastic Hinges Extracted from a Real Building

2017 NZSEE
Conference

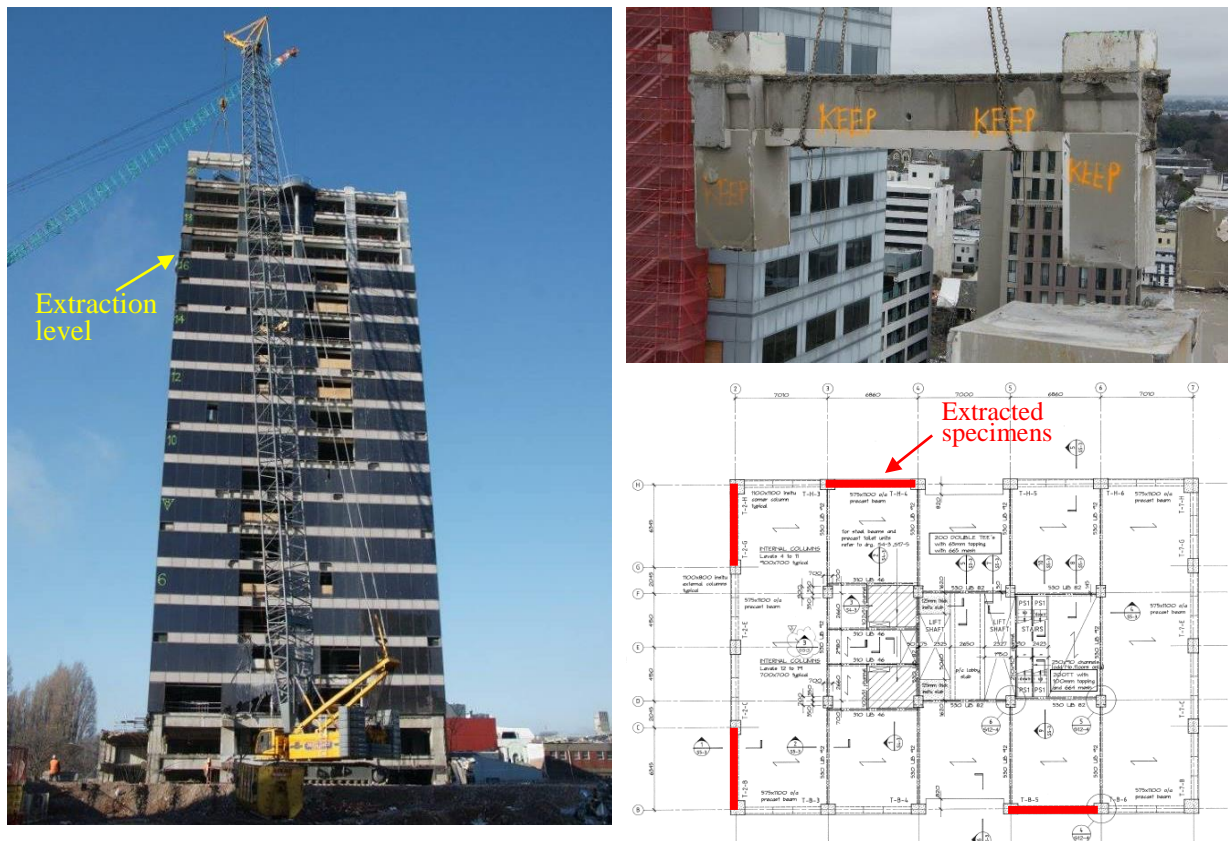
The PWC building (see Figure 1) was a 22-storey structure located on Armagh Street in the Christchurch’s Central Business (CBD) area. The lateral system comprised precast perimeter reinforced concrete (RC) frames with wet joints (typical of emulation of cast-in-place approach) in the beams at mid-span. The gravity system comprised precast double-tees with a reinforced concrete topping, supported on steel beams and concrete columns. The foundation system consisted of raft foundations. It was designed following capacity design principles and built in the 1980s. The perimeter frames had a hoop detail in the beam-ends intended to relocate the plastic hinge 500 mm away from the column face, so to avoid excessive demand and damage at the beam-column joint.

Figure 1. Elevation of the PWC building during the deconstruction process (left); extraction of one of the “H frames” (upper-right); typical floor plan view at the upper levels (lower-right), red lines indicate locations where the specimens were taken out of the 16th floor level.

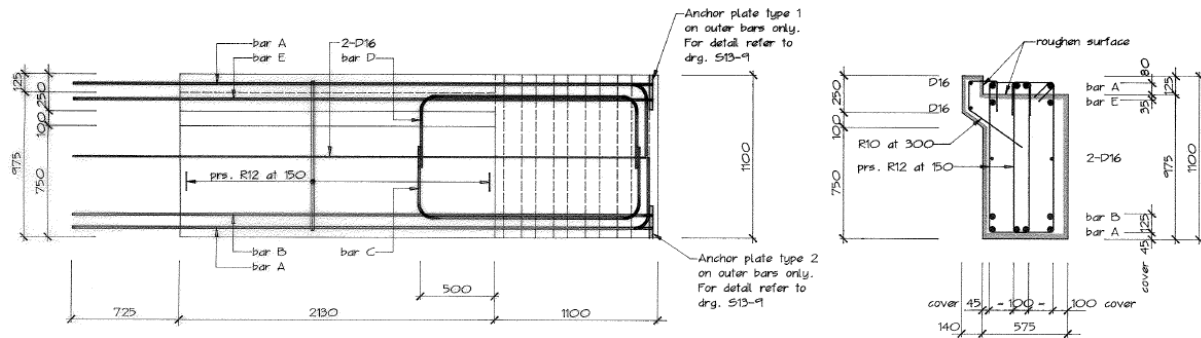
The “H frames” extracted during the deconstruction process were later cut in two “T-shape” specimens due to laboratory crane capacity limitations. Each of the “T-shape” specimens tested weighs between 10.5 ton and 13 ton. The beams are 2550 mm long (measured from the column face to the point of load application), 575 mm wide by 1100 mm high. The (main) longitudinal reinforcement consists of top and bottom 4 D-28 straight bars and 2 additional D28 hooked bars (within the plastic hinge relocation detail); the transverse reinforcement consists of 2 R-12 stirrups (one interior, one exterior) spaced at 150 mm crs. There is also secondary reinforcement detailed such that it provides vertical support to the flooring system (see Figure 3). The columns are 2700 mm long, either 1100 mm square (at the building’s corners) or 1100 mm by 800 mm (at the building’s interior columns). The nominal steel yield strength and concrete compressive strengths, as specified in the drawings, are 300 MPa and 30 MPa, respectively.

Figure 3. Typical section and elevation view of beams tested (Holmes Consulting Group).

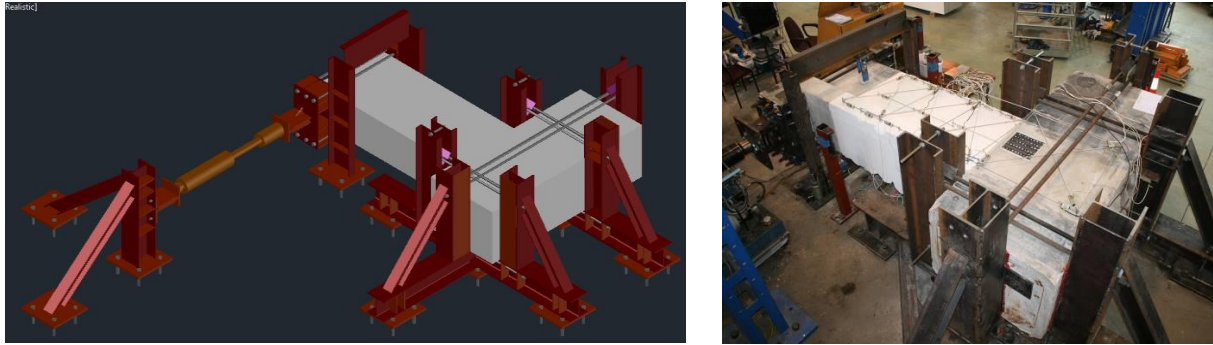
As shown in Figure 4, the reaction frame used for the tests consisted of steel braced frames anchored to the RC strong floor. The beam-column joint was placed horizontally on top of steel beams and clamped to the braced frames with steel channels and post-tensioned Macalloy bars. The beam-end was vertically supported on Teflon pads. A steel frame with a roller prevented the beam-end to uplift due to any accidental eccentricity that might occur at the actuator-to-beam connection. No axial and gravity loads were applied at the column (in addition to the resultant force from the post-tensioned bars) and beam, respectively.

Figure 4. 3D CAD view of the reaction frame (left); specimen 1 during the tests (right).

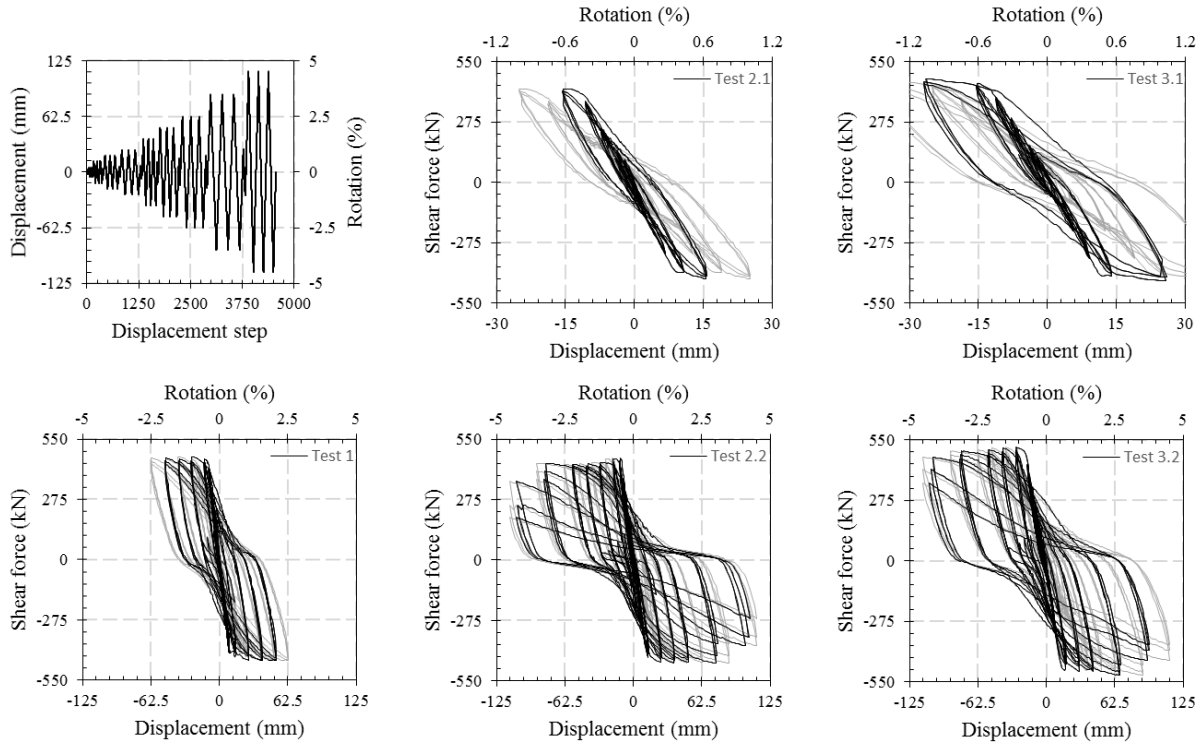
In Figure 10, solid grey lines represent force-displacement curves measured in “total” displacement units, whereas solid black lines are in “effective” displacement units (i.e., the “total” applied displacement minus the equivalent lateral displacement at the beam end due to rigid body translation and rotation). The onset of nonlinearity occurs at about 0.5% “effective” beam rotation. Rotation ductility demands of around 1.20 and 2.10 were achieved at the end of Tests 2.1 and 3.1, respectively.

All the tests show a relatively stable hysteretic behaviour at early stages, with however a sudden drop in strength during the last 3 cycles in both repaired configurations (Tests 2.2 and 3.2). Higher pinching behaviour, due to cracks opening and closing and more likely due to bond-slip degradation, was observed in the repaired configurations, in particular for Test 2.2.

When considering Test 3.2, the relocation of cracks outside the plastic hinge relocation detail led to higher shear forces for the same displacement demand and a more stable hysteresis loop with less pinching. Overall, the effective displacement (capacity) achieved in the test was lower than in other tests.

Figure 10. Applied loading protocol (upper-left), and force-displacement curves.

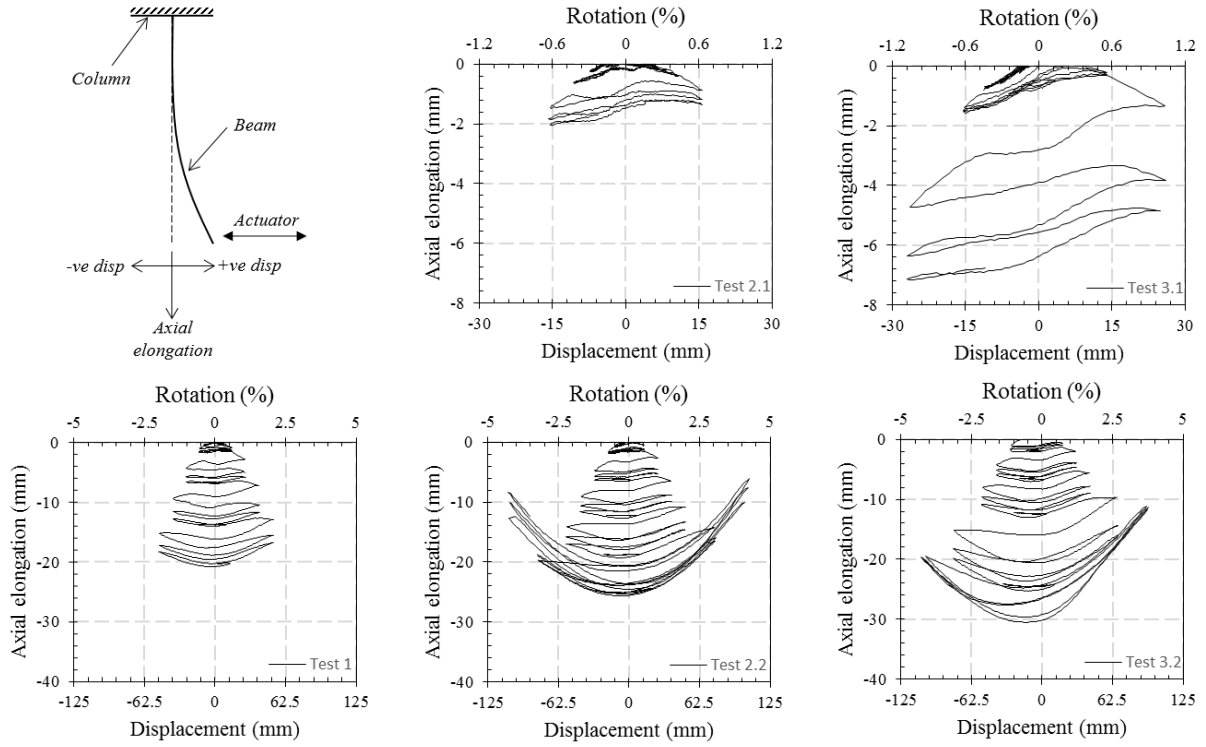
Figure 11 shows the axial beam elongation for all the tests. It can be noted that the beam elongation is permanent and cumulative. Maximum elongations in Tests 2.1 and 2.2 were 2 mm and 7.2 mm, respectively, equivalent to 0.08% and 0.29% increase in beam length. These beam elongations were consistent with the maximum cracks widths observed at the end of the tests. Maximum elongations in Tests 1, 2.2 and 3.2 were 21mm, 26mm, and 30mm, equivalent to 0.85%, 1.05%, and 1.20% increase in beam length, respectively. It is worth noting that the testing apparatus allowed for free beam elongation without any restraint action from the floor diaphragm as in fact would occur in the real building. Therefore, while the results are important to develop a better understanding of the behaviour of a “free” subassemblies, the beam elongation results are not fully representative of what we would have observed following the earthquakes.

Figure 11. Displacement sign convention (upper-left), and beam elongation curves.

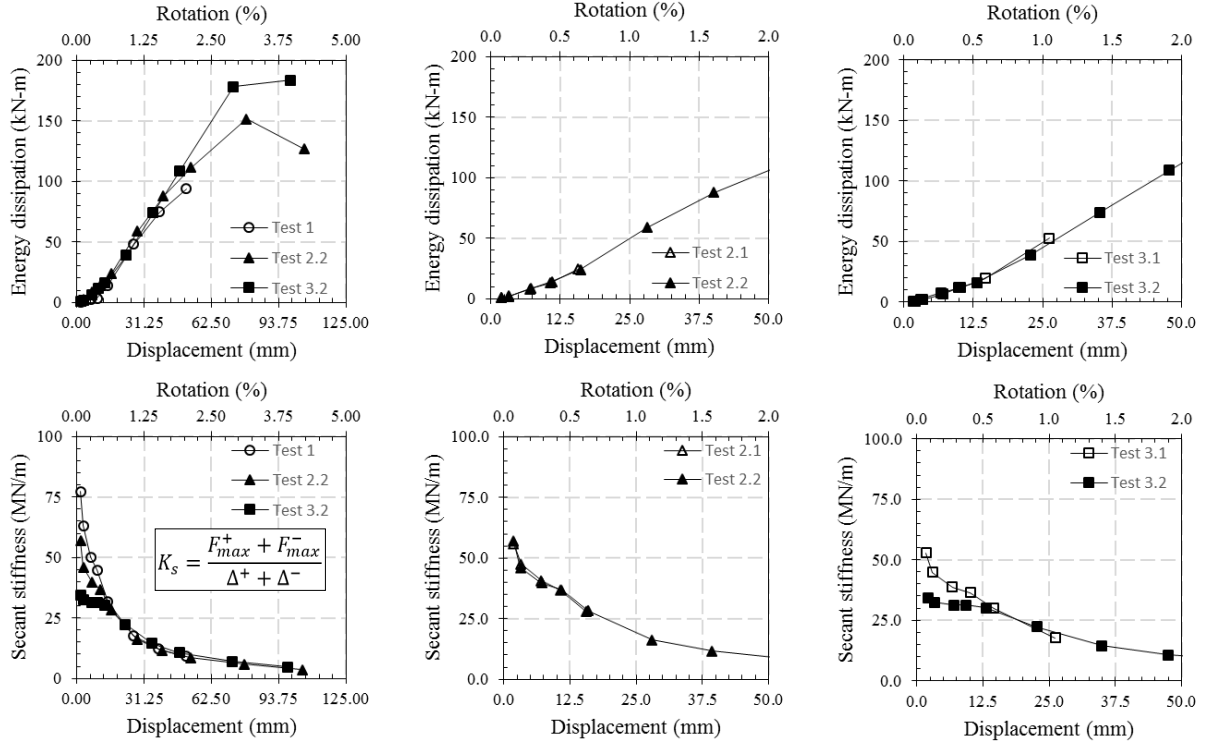
Figure 12 (top) shows cumulative energy dissipation computed as the sum of the area enclosed within the force-displacement curves, computed in “effective” displacement units. As shown in the figures, more energy is dissipated in Test 3.2 than in Test 2.2 (and arguably more than in Test 1 if we can infer that following the trend in the graph). This can be attributable to the less pinching as a result of more damage relocation (flexural type, outside the plastic hinge relocation detail). In general, reasonably good energy dissipation at both low (SLS) and high (ULS) rotation levels was achieved in the repaired specimens when compared with the slightly damaged specimen (Test 1).

Figure 12 (bottom) shows “peak-to-peak” secant stiffness for the first loading cycles, computed in “effective” displacement units as the slope of the line joining the maximum and minimum peaks in the force-displacement curves at each of the beam rotation levels.

As shown in the figures, there is a reduction of stiffness in the repaired specimens (both Test 2.2 and 3.2) at low rotation levels (below to the onset of nonlinearity, approximately) when compared with the slightly damaged specimen (Test 1). There is a better stiffness recovering (at low rotation levels) in Test 2.2 than in 3.2, possibly because of its lower damage condition prior to the repairs. The secant stiffness of Test 2.2 is also closer to the one obtained in Test 1, and the same in Test 2.1. In general, the secant stiffness does not seem to be significantly affected at high (ULS) rotation levels when compared with Test 1.

Figure 12. Energy dissipation (top) and secant stiffness degradation at 1st cycles (bottom) characteristics.

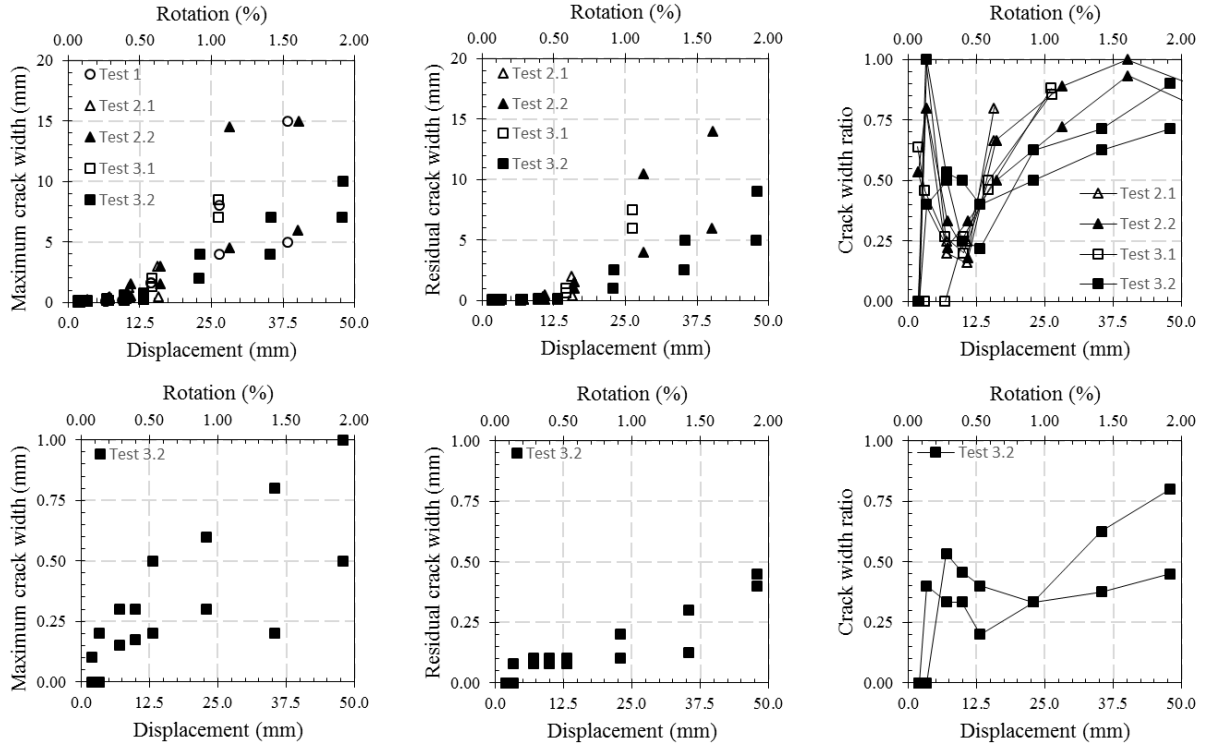
Figure 13 shows maximum and (static) residual crack widths measured during the tests. The top figures correspond to the most critical crack(s) observed within the plastic hinge relocation detail (i.e., shear-flexural cracks); the bottom ones correspond to flexural cracks observed outside the plastic hinge relocation detail during the Test 3.2. The maximum crack widths are measured at peak force, whilst the residual crack widths at zero force. Worth reminding that these residual cracks are “static” ones. The dynamics effects during the earthquake, as well as any axial load contribution, i.e. slab engagement effect resisting to the beam elongation, would further reduce them, thus increasing the maximum/residual ratio (Christopoulos et al., 2003; Pampanin et al., 2003).

Crack width ratios computed as the residual crack width upon the maximum residual crack width are also shown in the figure. It is evident how the crack width ratios are rotation (i.e. drift) dependant, showing a change of slope from negative to positive at rotations near or at the onset of nonlinearity. The negative slopes below the onset of nonlinearity are due to the fact that at low rotation levels the residual cracks are very small and almost constant (hairline-to-0.1 mm in width), regardless of the increase of the maximum crack widths as the rotation level increases. This is in line with recent post-earthquake observations (Pampanin et al., 2012; SESOC, 2011) where hairline-minor residual crack width could in fact hide non-negligible, if not significant, damage, including tensile fracture of the bars, especially in lightly reinforced shear walls.

Figure 13. Maximum and residual cracks, and crack width ratios within (top) and outside (bottom) the plastic hinge relocation detail.
